**CREL REPORT**

**99-4**

# **Investigation of the Roosevelt Road Transmitter Site, Fort Richardson, Alaska, Using Ground-Penetrating Radar**

March 1999

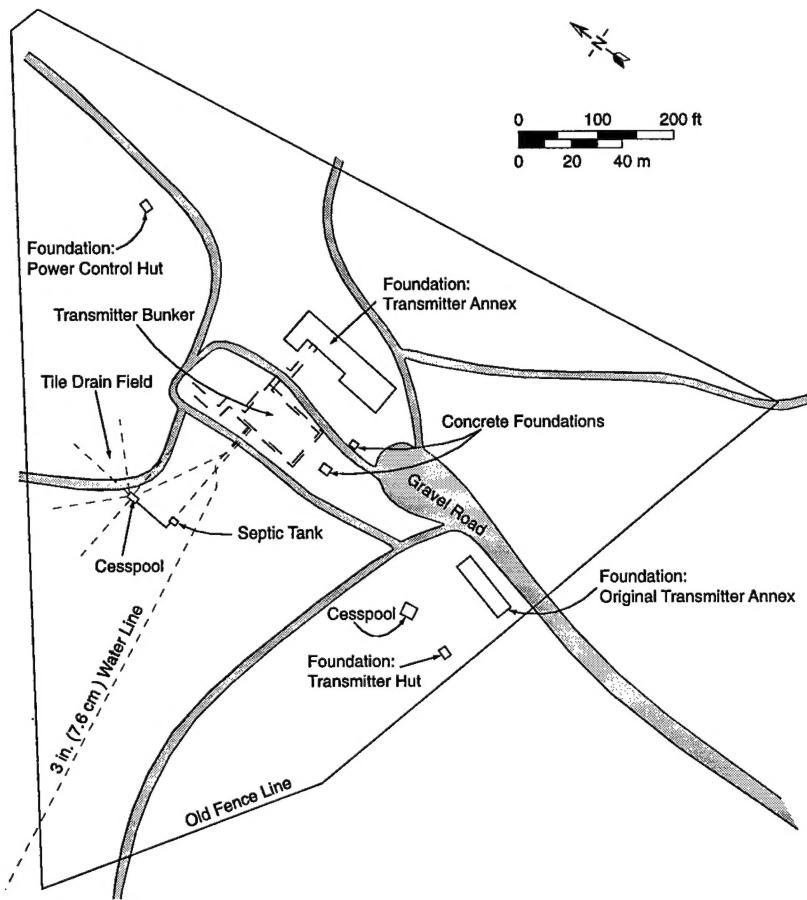
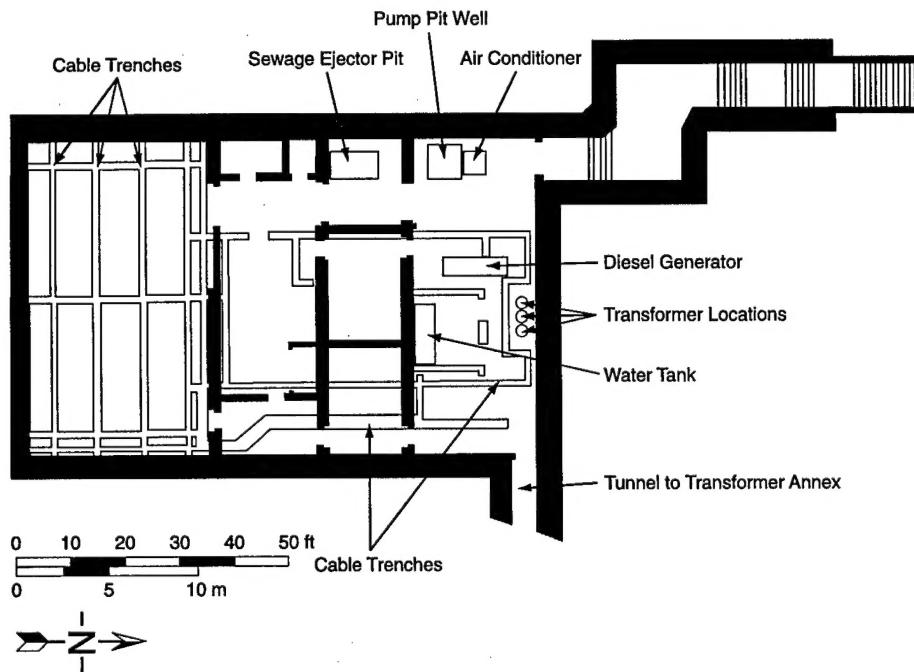
Figure 2. Roosevelt Road Transmitter Site.

The site became contaminated when the bunker and annex were vandalized in the 1970s. In the process of stealing copper wiring from floor trenches in the bunker and transmitter buildings, vandals toppled transformers (Fig. 2b) to uncover the wiring, which spilled dielectric oils contaminated with polychlorinated biphenols (PCBs) (Ecology and Environment 1996). In 1978, the above-ground structures were removed, leaving behind a number of concrete pads (Fig. 2a). The PCB-contaminated oils that had seeped into the foundation of the transmitter annex were cleaned up by triple washing the concrete with diesel fuel. However, some of this fuel spilled off of the pad, allowing PCB-contaminated diesel solvent to leach into the ground. Soil analyses in 1988 by the Corps of Engineers found PCB concentrations of up to 76,900 ppm near the east entrance of the bunker,

a. Transmitter site compound and associated structures.

b. Inner bunker and selected details of the structure.

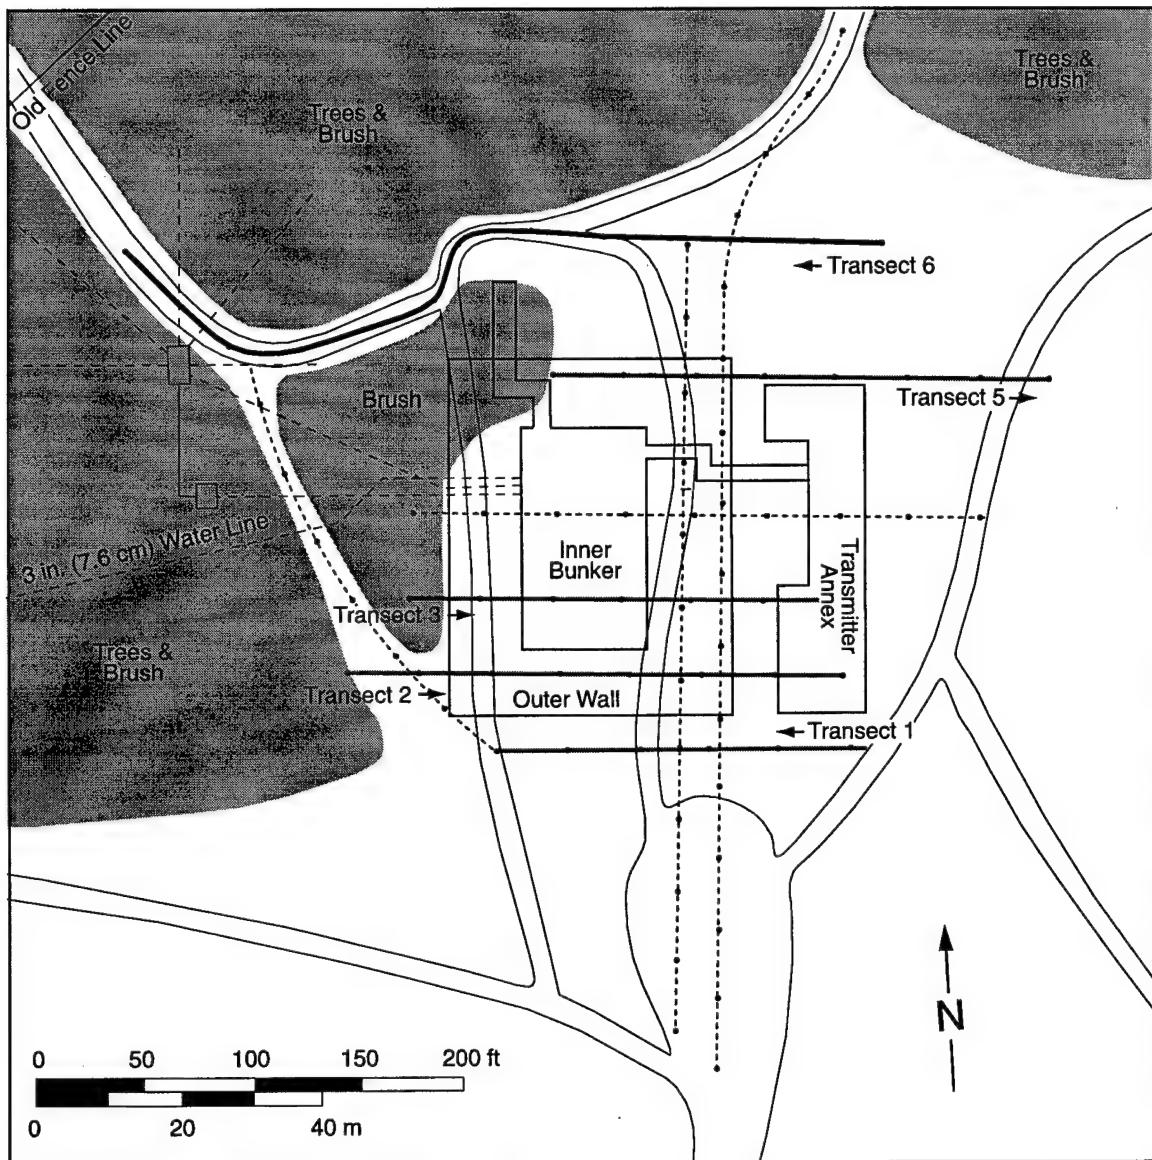
Figure 5. Layout of GPR transect lines at transmitter site. Transects discussed in this report are labeled. Arrows show direction of transect. Dashed lines show other transects run during study.

Eight transects were run near the bunker and transmitter annex, with five east-west transects selected for use in this report (1, 2, 3, 5 and 9; Fig. 5).

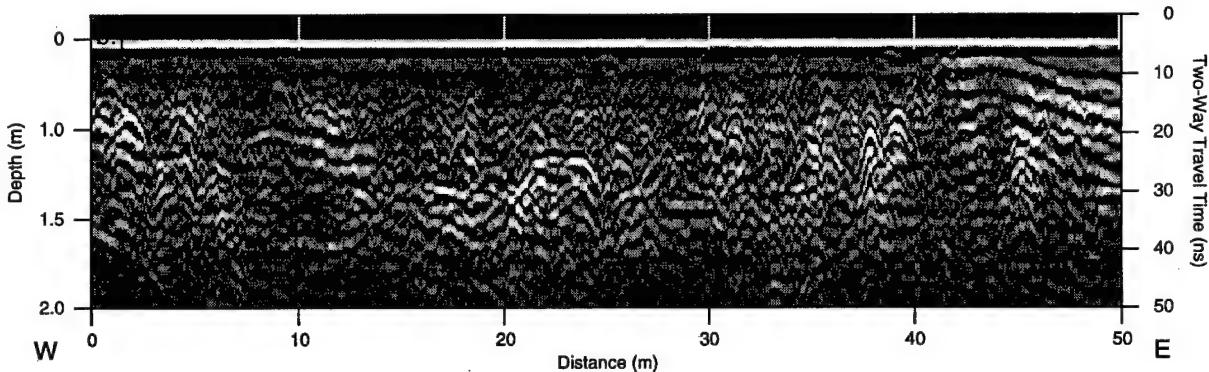
Figure 9. Profile recorded along transect 1 away from the bunker excavation.

This 50-m transect was located south of the known limits of the buried bunker and utilidors (Fig. 9 and 10). The 100-MHz profile shows a sub-surface horizon, which we interpret to be an excavation surface. It varies from a depth of 4 to 6 m, reaching its maximum depth about 18 m from the east side of the transect line. At distances of 0 to 10 m and 35 to 50 m along the transect, subhorizontal reflectors resembling fluvial layering are present at depths between 5 and 7 m. These deeper reflectors are truncated by a prominent horizon that appears to be the limit of an excavation (i.e., probably from the time of bunker construction; Fig. 9a and 10a). Fill above the excavation surface is characterized by closely spaced

The 400-MHz profile (Fig. 9b and 10b) shows details in the upper 1.5 m of the subsurface. There is a second discontinuous horizon that can be tracked from about 1 m depth at the east end of the transect to about 40 m distance, where it is truncated near the ground surface. This horizon reaches a maximum depth of about 1.3 m between 18 and 30 m along the line. Small diffractions at 2, 23, and 38 m originate about 20 cm above the discontinuous horizon. These diffractions probably originate from buried pipes or cables that were placed on a hard packed surface prior to backfilling.

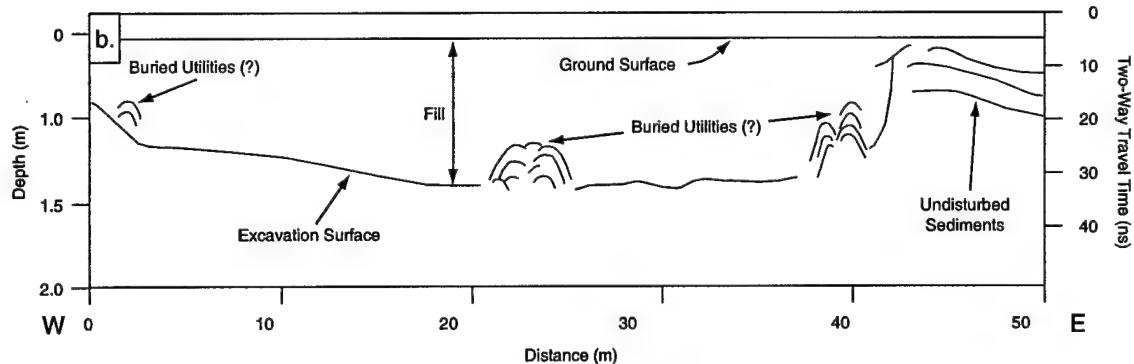
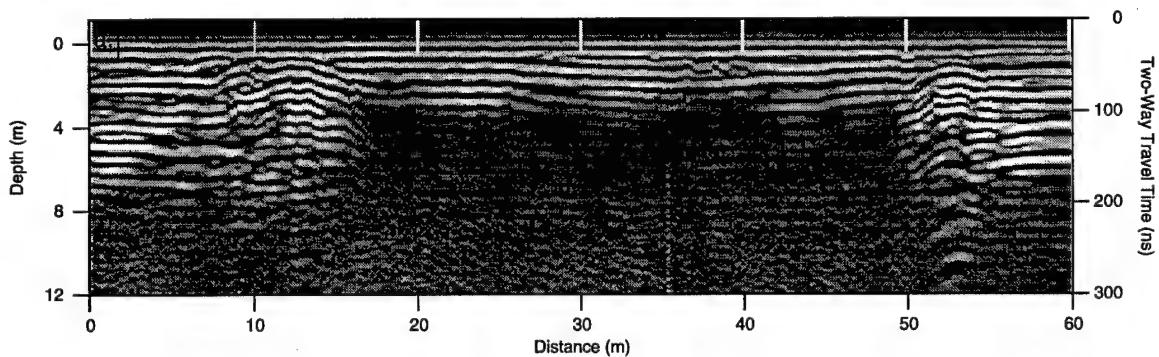
Figure 10. Interpretive depth sections for transect 1.

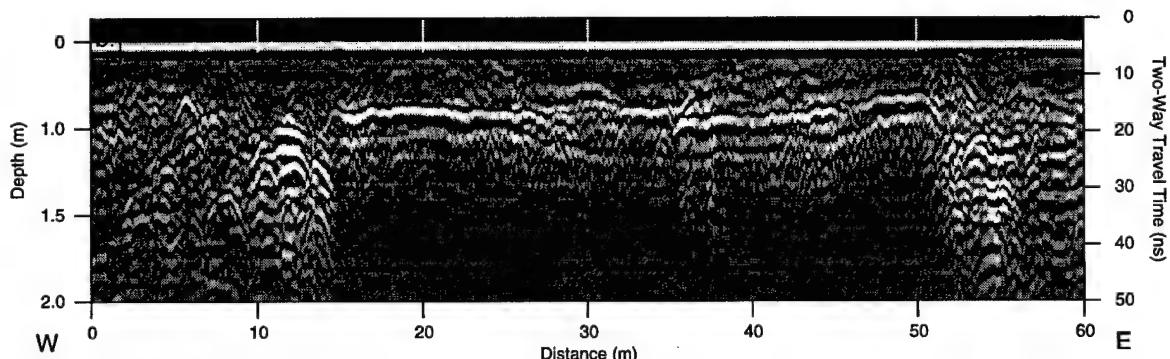
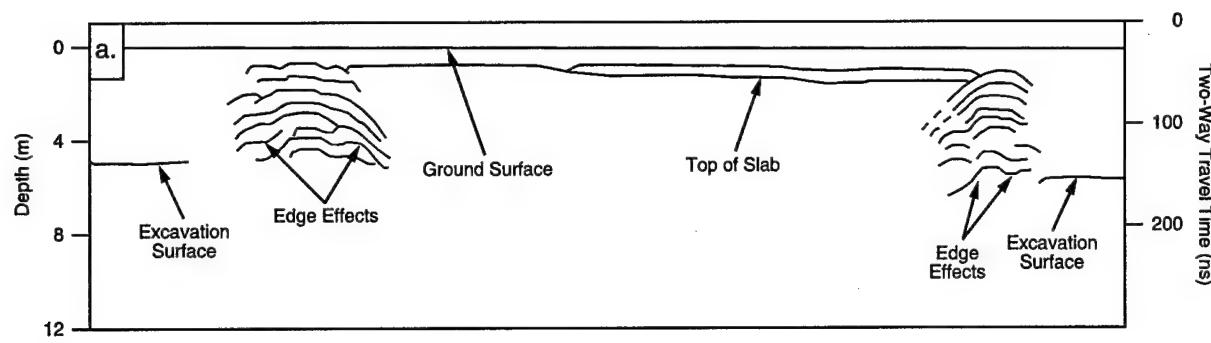
Figure 11. Profile recorded along transect 2.

Transects 2, 3, and 5 delineate the bunker and the adjoining utilidors. Transect 2 extends 60 m from the overgrowth west of the bunker to the top of the concrete slab of the Transmitter Annex at the south end of the bunker (Fig. 5). The 100-MHz profile is distinguished by the limited penetration where the antennas were directly over the bunker, and by strong diffractions at its edges (Fig. 11a and 12a). There is a near-horizontal reflector at a depth of 5 m on both sides of the bunker (Fig. 11a). The depth of this reflector corresponds to the strong reflector in transect 1 (Fig. 9a and 10a), suggesting that it is probably the same excavation surface. The reflection bands at a depth of 50 to 70 cm above the bunker (Fig. 11b) appear to reflect its upper surface (Fig. 12b).

The distinct horizon at 70 cm depth on the 400-MHz profile (Fig. 11b) represents the top surface of the bunker. A second, slightly deeper horizon of multiple reflections represents the steel rein-

forcement within the bunker roof. Close inspection of this horizon reveals that it contains many closely spaced, small diffractions from individual components of the steel reinforcement mesh. A series of hyperbolas apparent between 0 and 10 m distance define a ramp-shaped mound adjacent to the western utilidor. Its closeness to the utilidor suggests that it defines the surface of an earthen berm built during site construction.

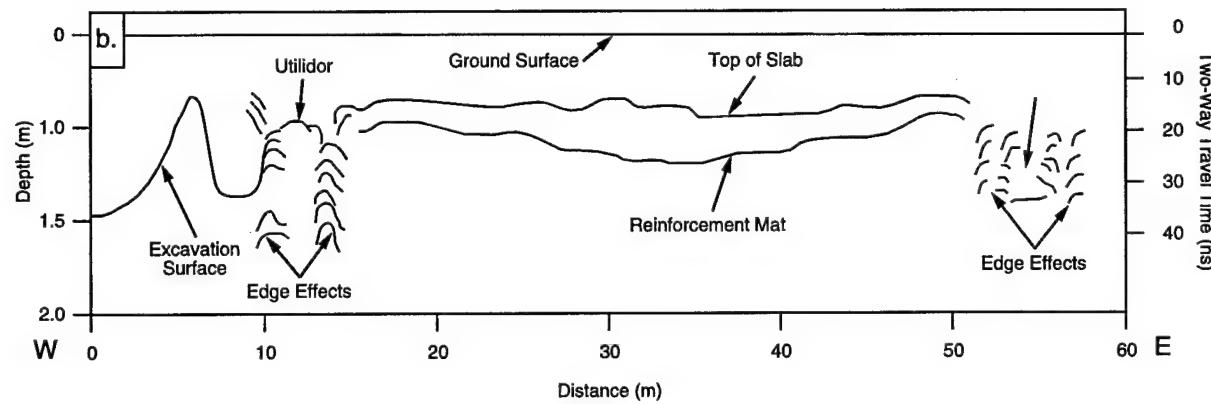
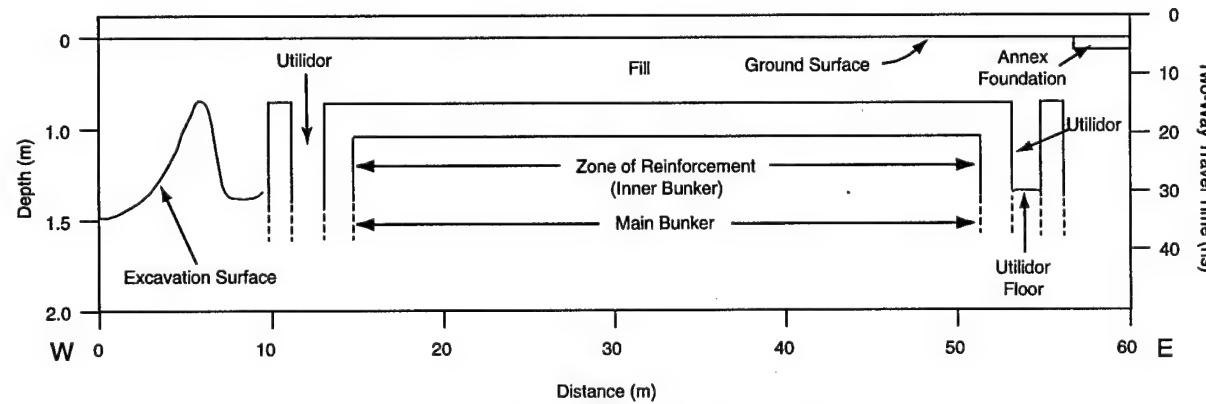
The 400-MHz profile shows distinct diffractions that originate from the utilidor structures on either side of the bunker (Fig. 12b). These diffractions appear as broad arches in the 100-MHz profile, where the wavelength is about 1.3 m long (Fig. 11a). Two distinct hyperbola sets can be distinguished in the 400-MHz data with the smaller (30-cm) wavelength (Fig. 11b). The higher resolution allows us to distinguish between the outer and inner walls of each utilidor. The top of the utilidor appears to be at about 1 m depth; a lower diffraction at 1.5 m depth and 54 m distance along the transect may locate the utilidor floor (Fig. 12b and 12c). Utilidors seen during the investigation were constructed of concrete walls, with railroad ties covered with soil for a ceiling and an earthen floor.

Figure 12. Interpretive depth sections for transect 2.

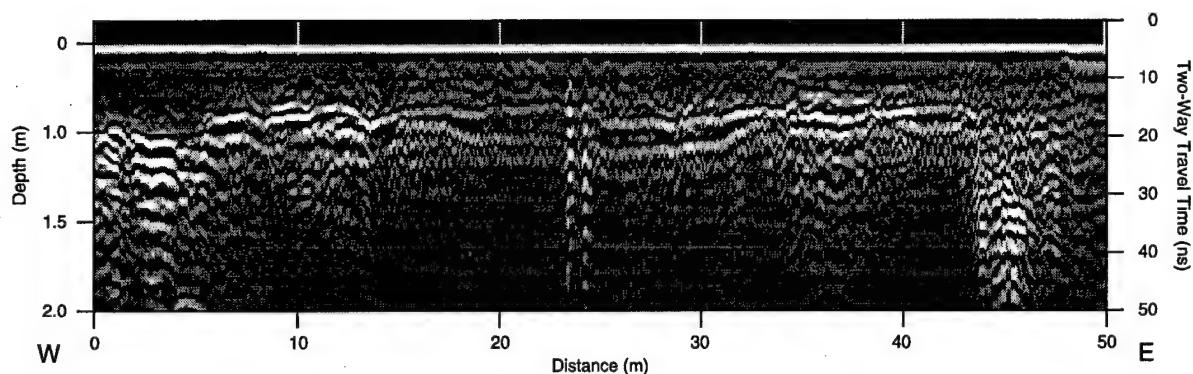
Transect 3 recorded at 400 MHz extends 50 m across the bunker, being approximately 10 m north of transect 2 (Fig. 5). The features recorded by this profile are similar to those of transect 2. The west utilidor is clearly evident between 3 and 4 m distance, as are the walls of the bunker. The small, closely spaced diffractions evident from 7 to 43 m indicate the steel reinforcement mesh (Fig. 13 and 14a). A tighter spacing of these diffractions and an apparent drop in the ceiling between the distances of 13 and 35 m suggest either a second reinforcement mesh or a double ceiling over an inner bunker (Fig. 14b). The breaks in small diffractions between 11–13 m and 35–38 m (Fig. 13) appear to be caused by edge effects and signal resonance at the outer walls of the inner bunker (Fig. 14b). A steel pipe, probably a vent pipe, was recorded at a distance mark of 23 m as a sharp resonance that extends through the entire record (Fig. 13).

Figure 13. 400-MHz profile recorded along transect 3.

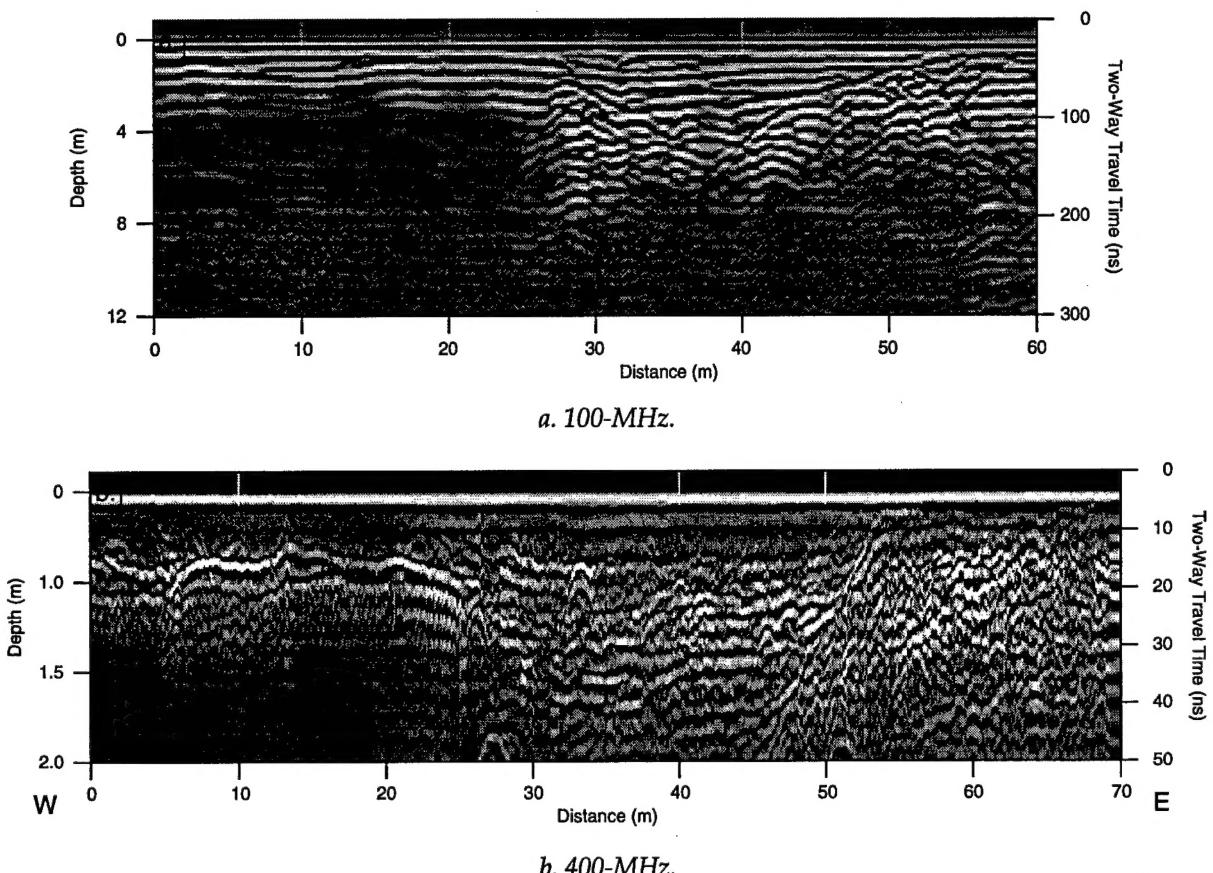
Transect 5 was located at the north end of the bunker and transmitter annex, extending towards the woods to the east (Fig. 5). The 100- and 400-MHz profiles record responses from the ceiling of the outer bunker, with its reinforcement mesh, and edge effects at the outer bunker wall and utilidors (Fig. 15 and 16a,b). Several horizons are apparent on the profiles east of the bunker. The horizons adjacent to the bunker are aligned subhorizontally, with occasional hyperbolas originating at reflector horizons. These horizons on-lap a westerly dipping horizon that truncates gently dipping reflectors to the east. We interpret the horizons closest to the bunker as layered fill. The westerly dipping horizon appears to be an excavation surface that truncates natural depositional horizons to the east. The hyperbolas in the fill probably represent buried objects, such as pipes and conduits, or boulders introduced during backfill (Fig. 15b and 16b,c).

Figure 15. GPR profile from transect 5.

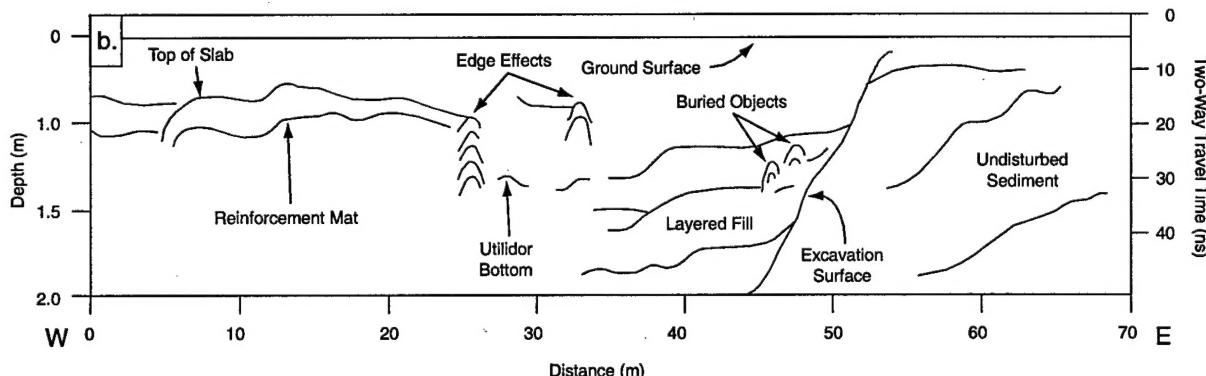
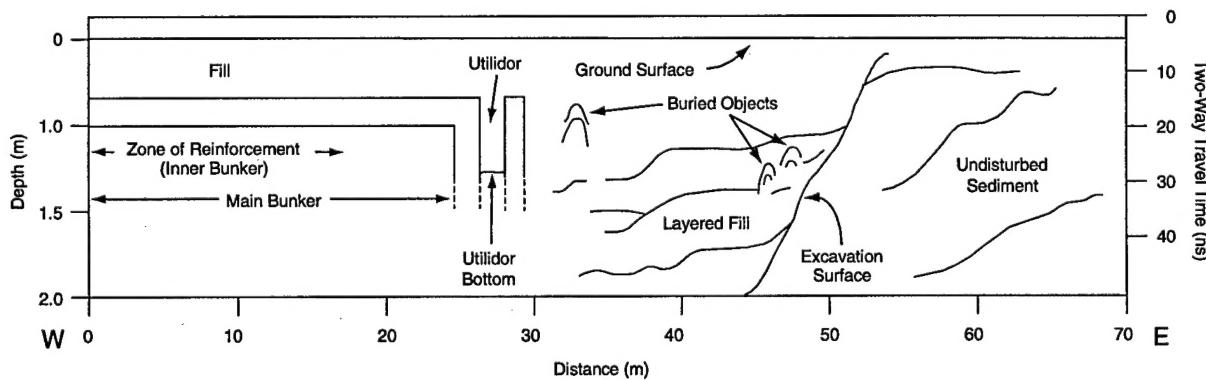
Figure 16. Interpretive depth sections for transect 5.

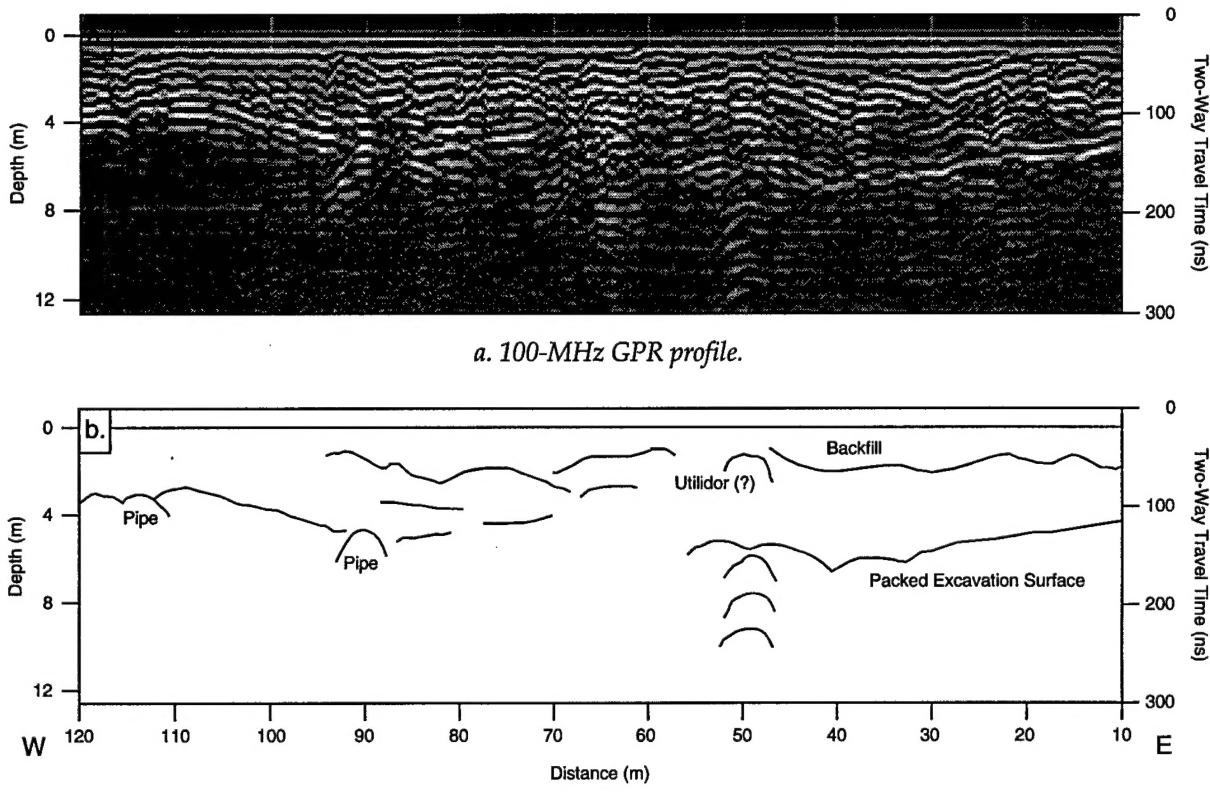
Transect 6 is located north of the bunker and extended 120 m (Fig. 5). The 100-MHz profile in Figure 17 shows a prominent reflector that extends across the transect between 4 and 7 m depth. This reflector truncates several smaller, less well-defined subhorizontal reflectors, likely to repre-

sent natural depositional surfaces as described on transects 2 and 5 (Fig. 12, 13, 15, and 16). We interpret this high-amplitude reflector as the lower excavation surface that became compacted during bunker construction. The hyperbolas recorded at 50 m distance likely record a utilidor that extends to the power control hut to the north (Fig. 2). Other coherent reflectors probably reflect sequential horizons produced as the site was backfilled.

Figure 17. Transect 6.
